# Seismic Assessment and Restoration Strategies for Cultural Heritage Buildings in the Neapolitan Area: The Case of Villa Vannucchi

Antonio Formisano \*

and Giovanna Longobardi

Department of Structures for Engineering and Architecture, School of Polytechnic and Basic Sciences, University of Naples "Federico II", Piazzale Tecchio 80, 80125 Naples, Italy; giovanna.longobardi@unina.it

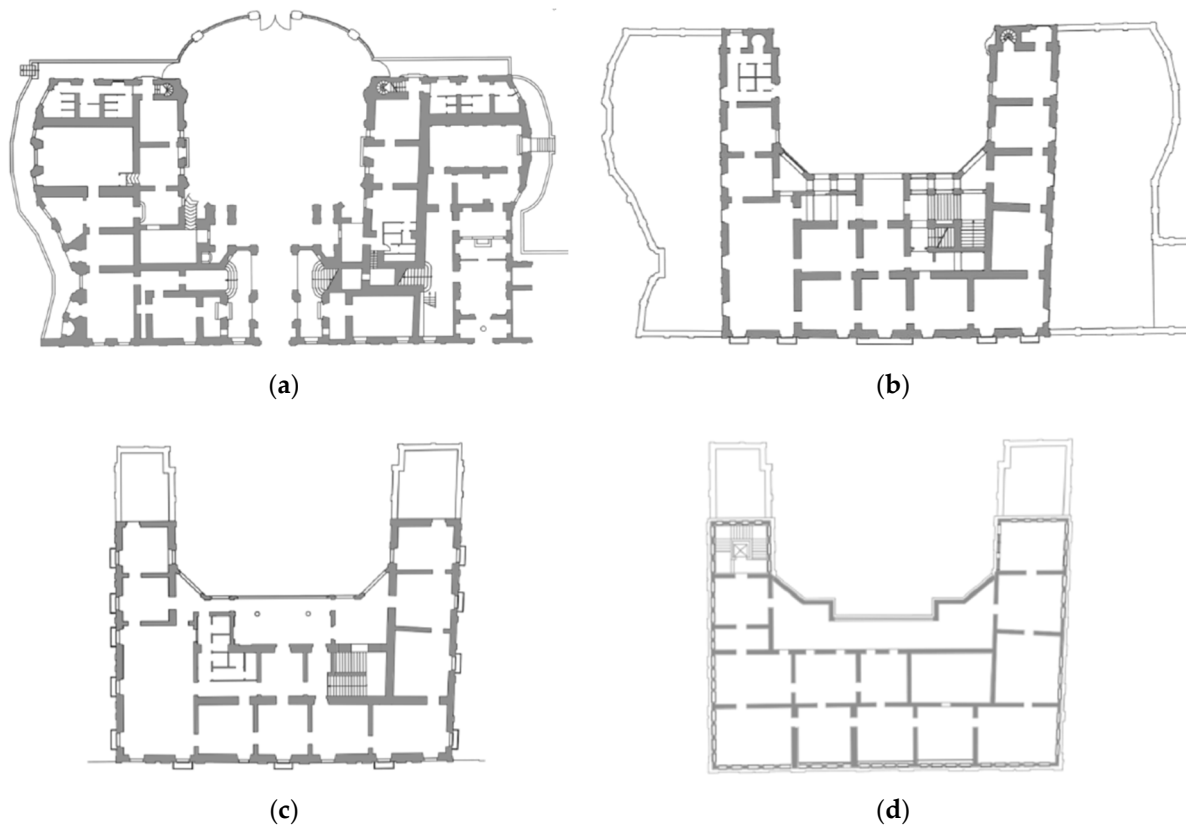
The mansion has a “U-shaped” layout, with the central body consisting of three levels and the two lateral bodies comprising a single floor. The vertical walls are made of yellow tuff masonry, a typical material of the region, bonded with mortar. Wall thickness ranges between 60 and 80 centimetres. The ground floor rooms are covered with masonry vaults of varying geometries, while the upper levels feature intermediate floors made of chestnut timber beams, another traditional material used in the region for its durability and resistance, with a single layer of planks. The roof, also constructed with chestnut timber beams and tiles, has a double-pitched configuration.

**Figure 3.** The storeys of the historic construction: (a) ground floor; (b) first level; (c) second level; (d) attic level.

Figure 3 illustrates the three-storey layout of the construction.
