Article

Seismic Vulnerability Assessment and Sustainable Retrofit of Masonry Factories: A Case Study of Industrial Archeology in Naples

2. The Decommissioned Factory in the Suburb Area of Naples

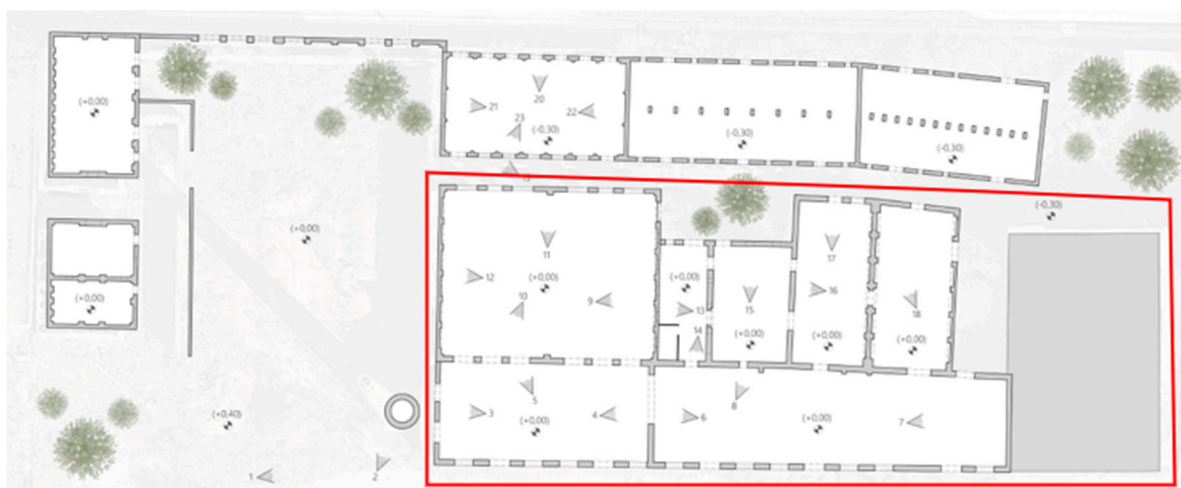
Figure 3. Identification of the production buildings under evaluation.

The selected structures are identified in Figure 3.

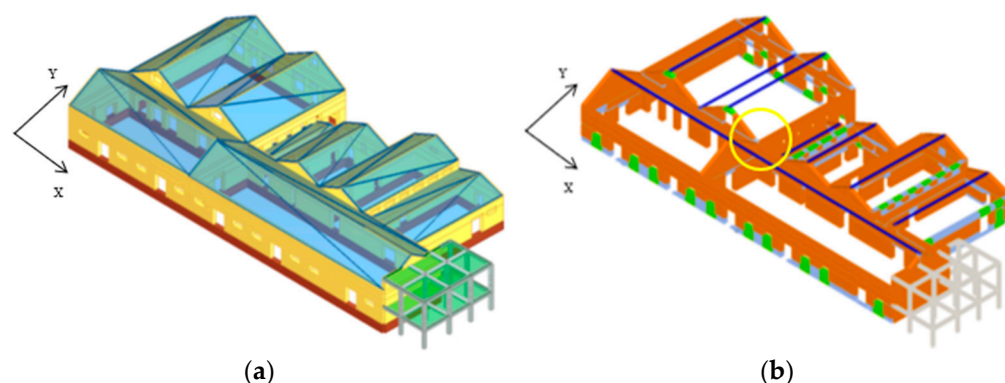
Figure 4. (a) Three-dimensional view of the structure numerical model; (b) meshed model of the structure with masonry piers (in brown), spandrels (in green), rigid nodes (in light blue), steel elements (in blue), and reinforced concrete columns (in grey). The yellow circle indicated the position of the control node.

Figure 4 illustrated the three-dimensional and the meshed models of the structure with the identification of the three macro-elements mentioned above.

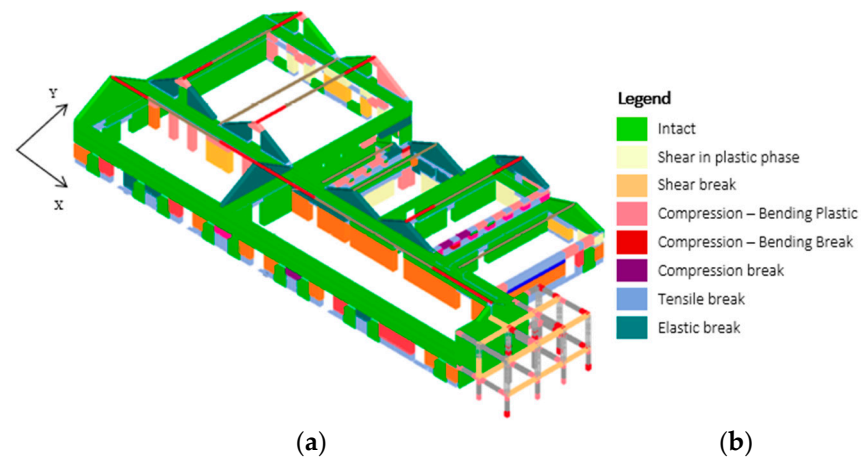
According to Figure 5, which depicts the damage incurred by the complex of fabrics along the most vulnerable direction (Y), the primary issue observed is the shear mechanism affecting the vertical panels of the two largest structures. Several panels exhibited signs of tensile failure, and certain masonry parts at the roof level experienced compression-bending phenomena.

Figure 5. (a) Damage on the structure 3D model along the Y direction; (b) legend of mechanisms.

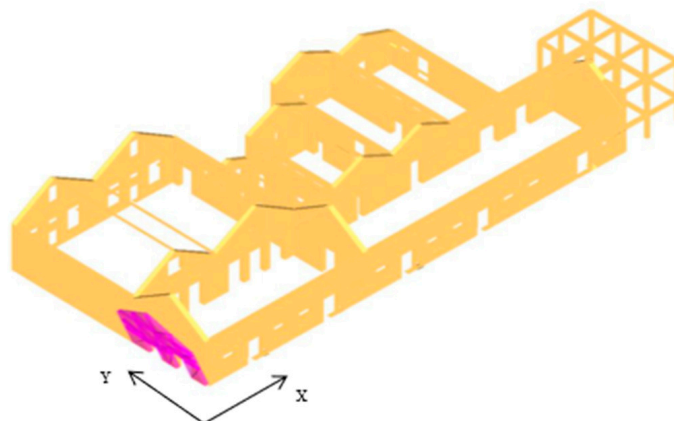
Figures 6 and 7, along with Table 5, point out that in both cases the checks for the two analyzed walls are not satisfied, leading to their overturning.

Figure 6. Overturning mechanism of Wall 1.

| Wall | Constraint | a_0^* | $a_{0,min}$ | Result |
|---|---|---|---|---|
| 1 | Ground | 1.375 | 2.404 | Not Verified |

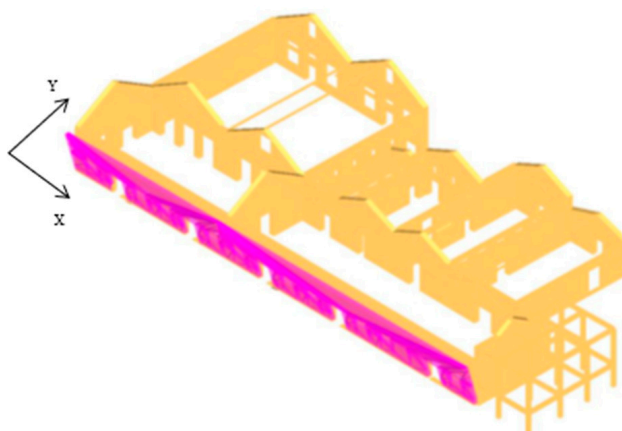
Figure 7. Overturning mechanism of Wall 2.

| Wall | Constraint | a_0^* | $a_{0,min}$ | Result |
|---|---|---|---|---|
| 2 | Ground | 1.909 | 2.404 | Not Verified |
