# Numerical calibration of an easy method for seismic behaviour assessment on large scale of masonry building aggregates

Antonio Formisano\*, Gilda Florio, Raffaele Landolfo, Federico M. Mazzolani

University of Naples "Federico II", Department of Structures for Engineering and Architecture, Naples, Italy

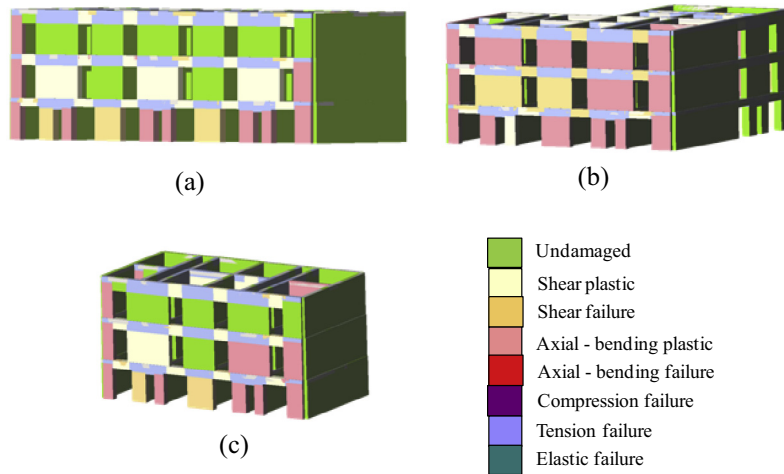
Fig. 6. Collapse mechanisms of different FEM models (plan interaction).

All the achieved results are summarised in Table 2, whereas in Fig. 6 the failure modes of the structural unit within aggregate are shown. It is apparent that the lower vulnerability index is attained when building is within two edifices.

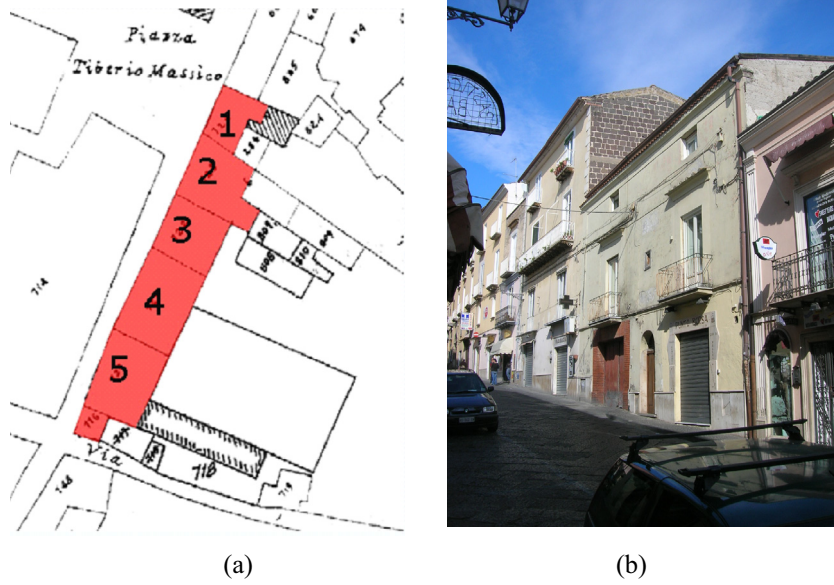
Fig. 21. The aggregate investigated in Sessa Aurunca: plan layout (a) and 3D view (b).

The case study consists on a building aggregate composed of five different units having a vertical structure made of squared tuff masonry stones (Fig. 21). The compound expands along a curtain on the street and has an elongated shape. The buildings are developed on 3–4 storeys, having generally vaults at the ground floor, mixed r.c.-tile or steel-tile floors on other storeys and pitched

wooden roofs with tie beams. Units n. 2, 4 and 5, visible in Fig. 21, were subjected to retrofitting interventions after the 1980 Irpinia earthquake. More details on this case study are reported in [17].

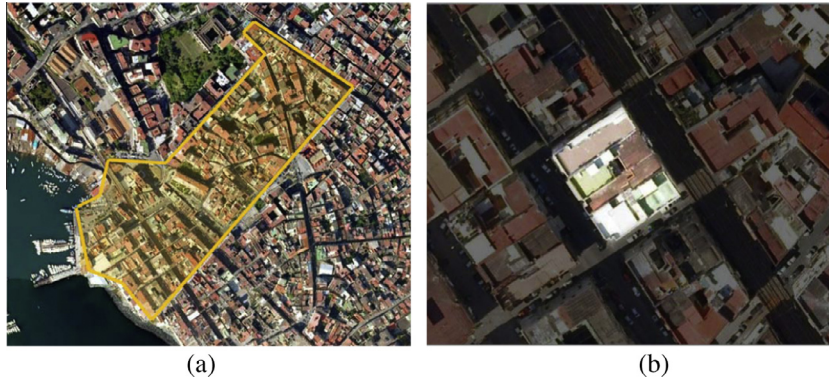
Fig. 25. The investigation pilot area (a) and the bird-eye view of the study masonry aggregate (b) of the historical centre of Torre del Greco.

The proposed methodology has been used to assess the seismic vulnerability of a part of the historical centre of Torre del Greco (Fig. 25a). This city, about 20 km far from Naples, is one of the municipalities most exposed to the Vesuvius risk, since it was destroyed in the eruption of 79 AD. For this reason, the WG4 ‘Risk

Aiming at validating the proposed survey form, the analysis of a case study represented by an existing masonry building aggregate in the historical centre of Torre del Greco has been done. The examined masonry compound (Fig. 25b), which consists of five tuff masonry stones units structurally dependent each other, has a regular plan layout and covers a total area of about 877 m<sup>2</sup>.

Once the analysis method implemented for building aggregates has proved its effectiveness, it has been used to investigate the seismic vulnerability of the entire pilot area of the historical centre of Torre del Greco (Fig. 25a).

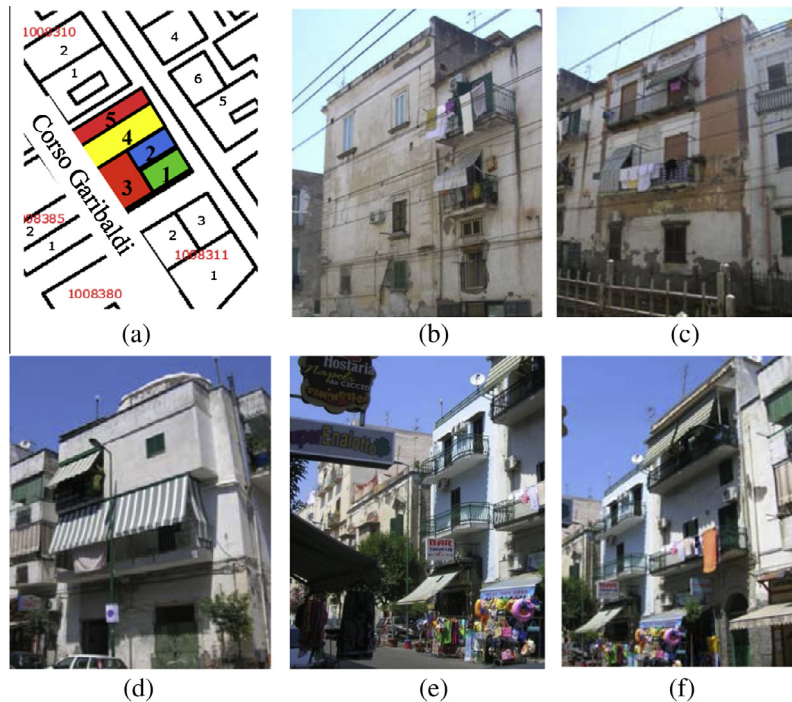
Fig. 26. The aggregate investigated in Torre del Greco: (a) plan view; (b) building n.1; (c) building n.2; (d) building n.3; (e) building n.4; (f) building n.5.

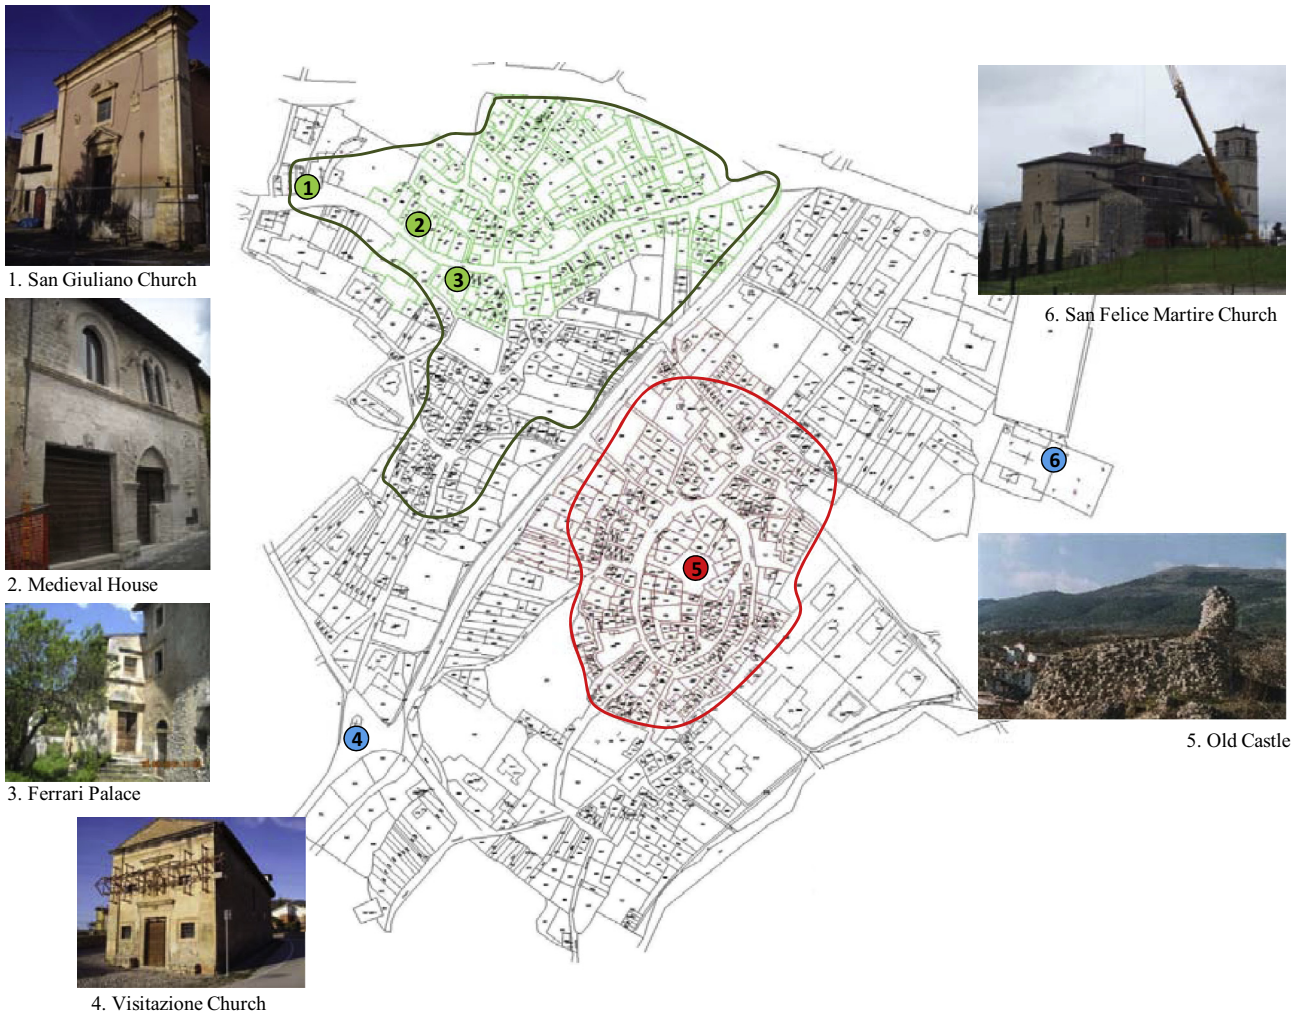
Fig. 36. Urban morphology and monumental constructions of Poggio Picenze.

The historical centre is the result of the process of continuous urban growth from the ancient times up to the present days. In particular, the farming town can be divided into two different urban areas (Fig. 36). The oldest nucleus was founded by Piceni around the 3rd century BC on the slope of Mount Picenze. The subsequent urban configuration developed around the medieval castle built approximately in the 1st century AC. Originally, the ancient castle had fortified walls and six towers, including a high one in the middle. Therefore, in the oldest part, the urban planning is typical of a medieval town with buildings arranged in almost concentric arrays which follow the contours.

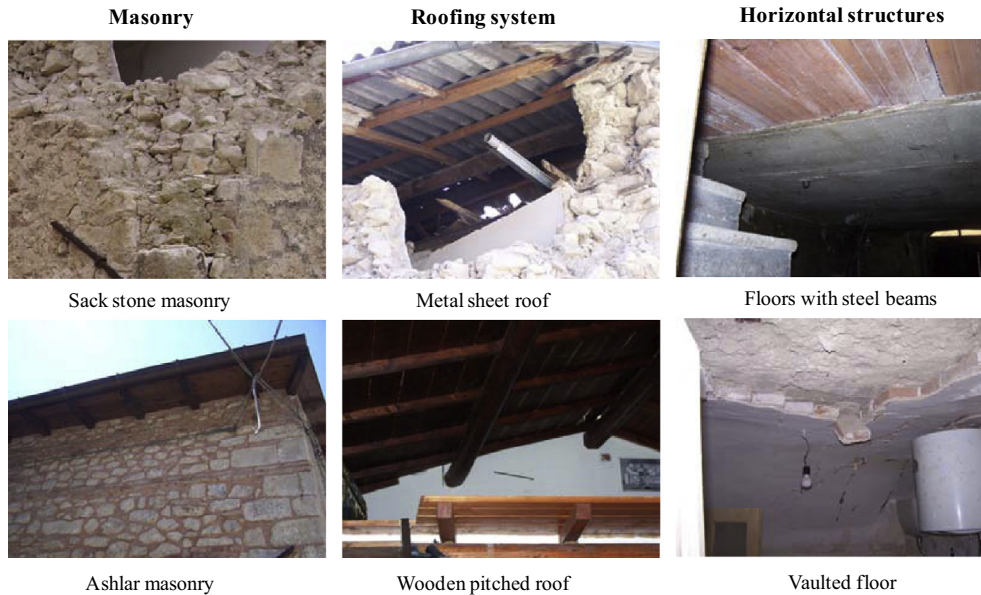
Fig. 37. Main structural features of masonry aggregates of Poggio Picenze.

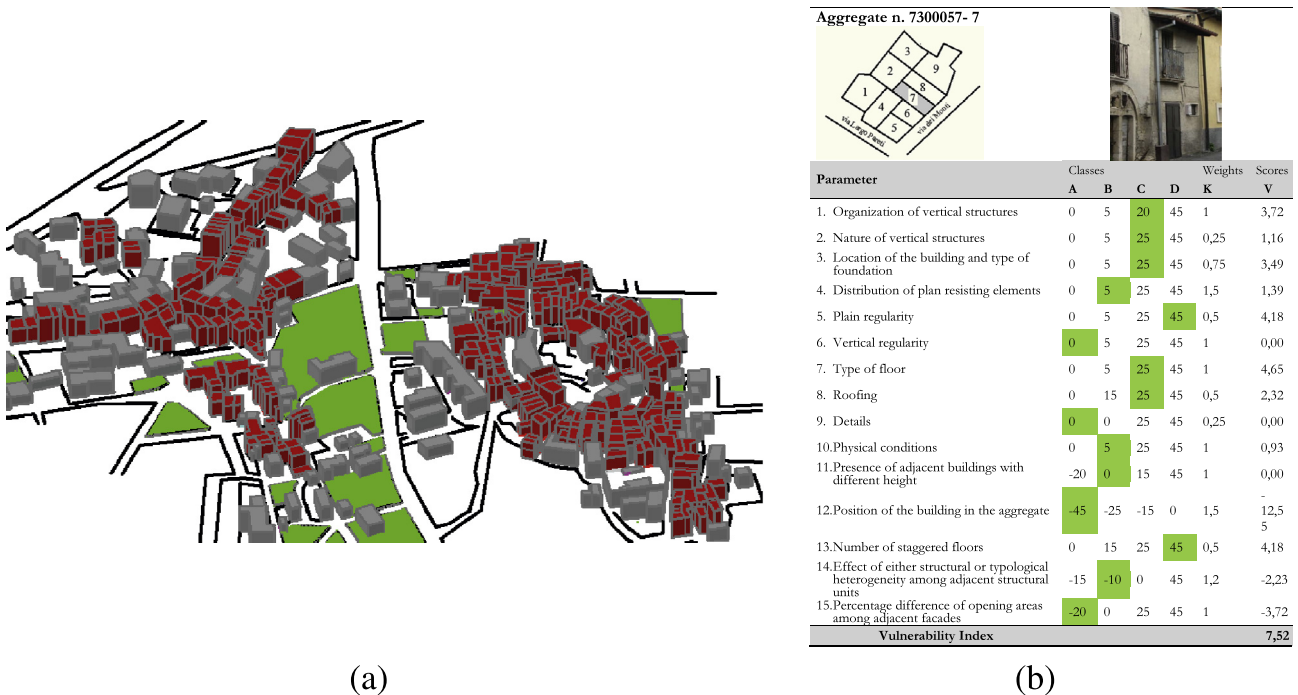
Fig. 40. Seismic vulnerability assessment of the historical centre of Poggio Picenze: the examined aggregates (a) and a typical form filled for a given aggregate structural unit (b).

independent units (Fig. 40). For each building, the vulnerability index has been computed by filling the form reported in Section 2.1.

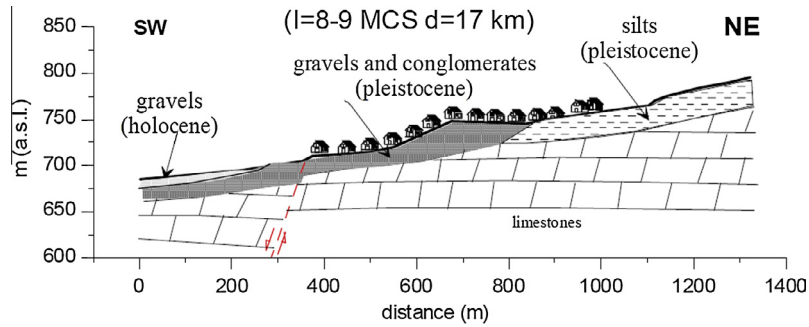
Fig. 41. Schematic geological cross-section of Poggio Picenze [32].

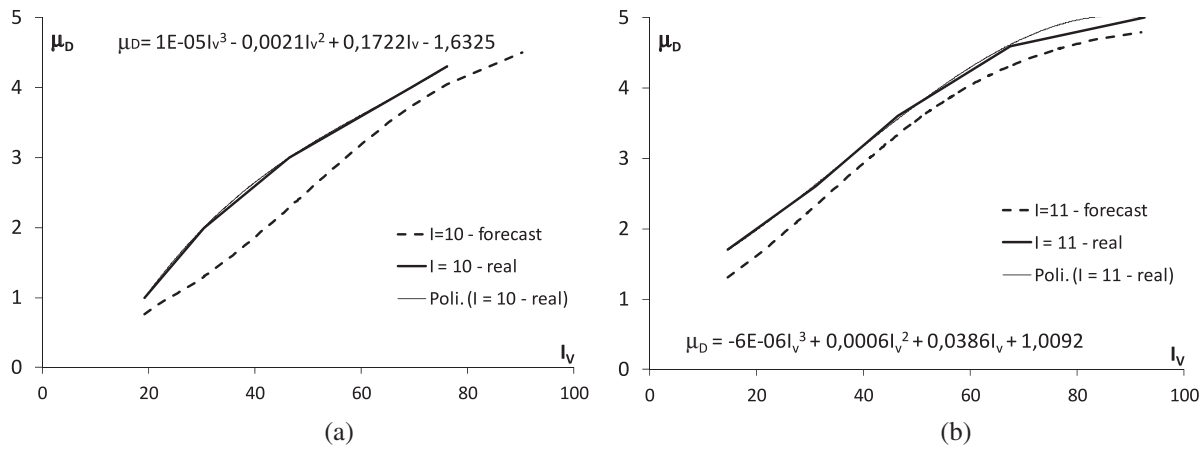
Fig. 42. Comparison between the expected mean damage grade and the occurred one within the building aggregates of Poggio Picenze: the west zone (a) and the castle area (b).

From visual survey it was noticed that in the castle zone, the old buildings were heavily damaged, whereas minor damage was

detected in the western and downhill parts of the town, where the foundation soil is based on the coarse-grained Pleistocene formation.
