# IMPROVING RESILIENCE IN ARCHITECTURAL HERITAGE? THE RECONSTRUCTION OF THE VAULTING SYSTEMS AFTER THE 1805 EARTHQUAKE IN MOLISE (ITALY)

L. Romano<sup>1</sup>.\*

<sup>1</sup> Dept. of Architecture, Università degli Studi di Napoli Federico II, Naples, Italy - lia.romano2@unina.it

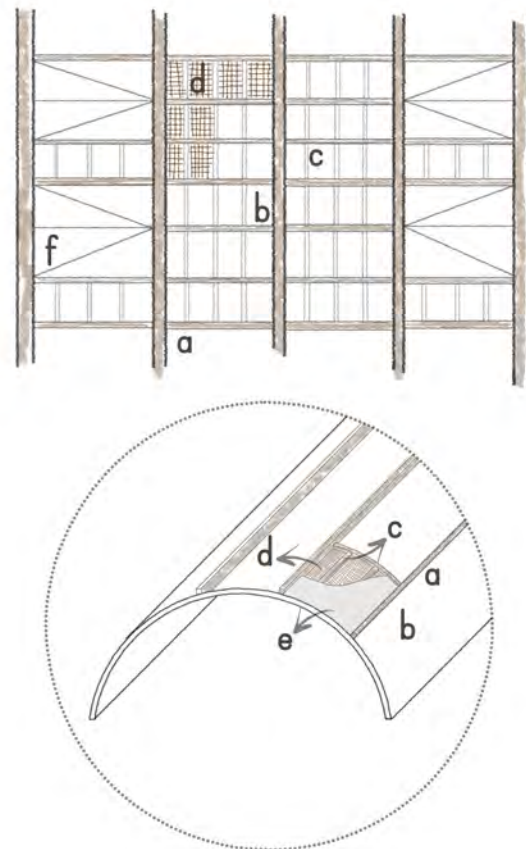
Figure 1. Explanatory sketch of the wooden vaults: plan and axonomy. Legend: a: filagne; b: jattole; c: contrasti; d: stuoiato (reeds); e: lime&gypsum coat; f: lunettes (Romano).

In addition to the well-known wooden vaults (so-called *incannucciate*) already widespread in the 18th century in the Neapolitan area and in other contexts of southern Italy (Abruzzo, Campania, Sicily), the Molise case recorded the use of a variation of the traditional wooden vault, characterised by higher resistance thanks to the presence of a lime and gypsum coat at the extrados and called *a colo di gesso*. The adoption of this construction system appears to have been ascertained, through direct investigations and archival documents, in numerous ecclesiastical architectures in Molise. The structure of the vault is composed by beams arranged longitudinally called *filagne*, by a frame of stakes (*jattole* or *ghiatte* and *contrasti*) and by a layer of reeds (*stuoiato*) covered by a coat of gypsum and lime. The *stuoiato* was produced through the use of good quality reeds which, depending on the cut and the intersection between the parts, could appear more or less complex and refined (Figure 1).

In the archival documentation they are defined as "strong enough to walk on, and light"<sup>2</sup> even if highly vulnerable and subject to sudden collapse if not well built. Moreover, the system is partially suspended, through thin wooden rods, called *rielle*, from the truss roof above.

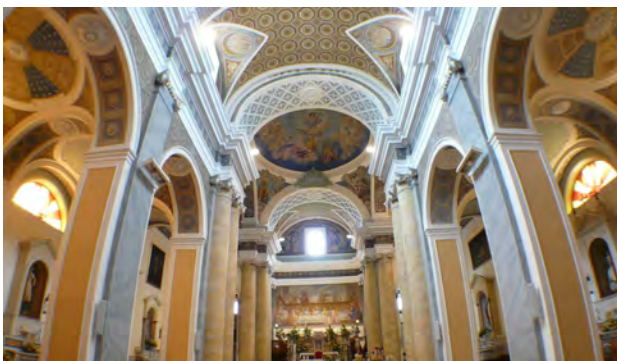
Figure 2. Baranello (Campobasso). Church of St. Michele Arcangelo: the main nave (Romano, 2016).

The barrel vault with lunettes covers the nave, measuring about 8 x 14 metres and resting on vertical partitions 80 centimetres thick (Figure 2). The wooden structure, consisting of four *filagne*, shapes the form of the vault and the side lunettes generated by three small wooden stakes (*jattole* or *ghiatte*) connected to the longitudinal elements. Each *filagna* is joined to the truss, made up of seasoned oak wood, by the *rielle*<sup>4</sup> (Figure 3).

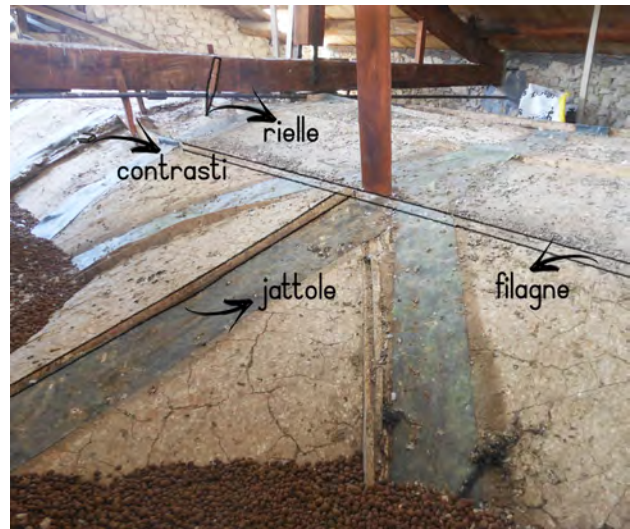
Figure 3. Baranello (Campobasso, Italy), Church of St. Michele Arcangelo: extrados of the wooden vault covering the central nave (Romano, 2016).

An emblematic case referable to the interventions carried out following the earthquake of 1805 is represented by the vault of the nave of the church of San Michele Arcangelo in Baranello, in the province of Campobasso. The possibility of making a direct analysis of the structure and its extrados allows the identification of the structural vulnerability factors. The vault – made up of a slender wooden and reed frame, covered with a cast of conglomerate of lime and gypsum – is partially suspended from the wooden truss and, therefore, in case of movement of the same, subject to possible phenomena of local instability. It would be appropriate, therefore, to evaluate the possibility of isolating the two systems in order to avoid potential instabilities and to consider to what extent the use of Fiber Reinforced Polymers (FRP) could contribute to the effective improvement of the behaviour of the structure or, on the contrary, trigger possible future collapses.

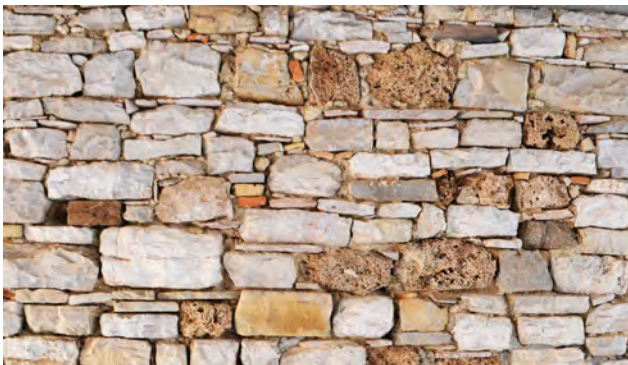
Figure 4. Frosolone (Isernia, Italy): the photo shows a masonry of limestone and *cimenti* (Romano, 2016).

Leaving aside the brick vaults, considered too expensive for a small ecclesiastical building like the one in the Civita of Bojano, the sole solution for the technician was individuated in the *cimenti*, a stone probably belonging to the travertine family (Penta 1935), particularly porous and lighter than the white and pink limestone, widespread in the lower Molise and referred as *pietraviva* in the archival documentation (Figure 4).

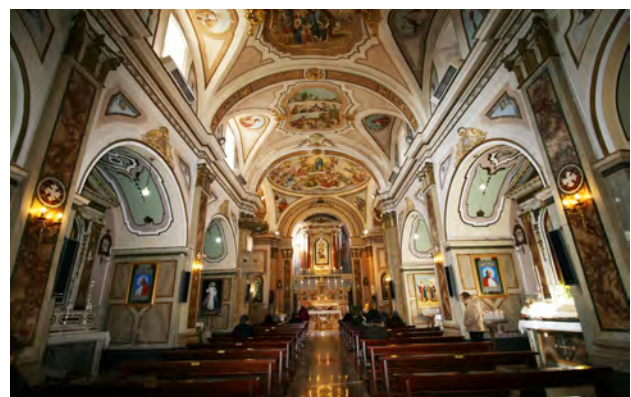
Figure 5. Sant'Elena Sannita (Isernia). Church of St. Michele Arcangelo: the main nave (Romano, 2016).

The use of the *cimento* appears widespread in numerous ecclesiastical and civil buildings in the region such as the parish church in Sant'Elena Sannita (Isernia) and the cathedral of Isernia (Figure 5).
