# **Re-shaping the construction industry**

## “LCC analysis for glued laminated timber components exposed in external”

**Topic:** *Life Cycle Management*

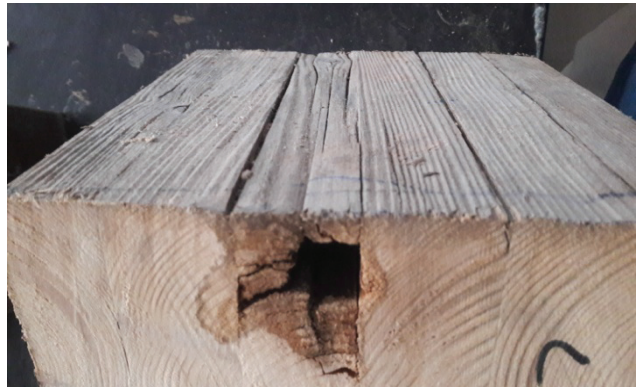
Fig. 6 – Degradation in a cross section

In addition, it is necessary to point out a further anomaly in both cases, that is the orientation chosen for the positioning of the elements: in fact, it is parallel to the layers, unlike the natural layout of these elements, which would clearly recommend a laying with vertical axis orthogonal to the layers.

In this way, the incorrect positioning on the one hand does not allow the glued laminates timber elements to express all the potential mechanical performances, on the other it abnormally exposes the beams to the action of the atmospheric agents, since all the glued surfaces are orthogonal to the meteoric waters coming in zenital direction. The observation of the beams in site highlights the presence of a strong degradation of the elements, more accentuated on the most exposed surface. It follows that the material, although treated on the surface with protective paint, shows a limited aptitude for direct exposure to atmospheric agents. (Figures 6 and 7).

The case study has highlighted how, at present, it is necessary to fully replace the beams, given the extent and intensity of performance decay, which led them to the end of their life cycle (can be estimated, under this specific conditions, about 10 years).

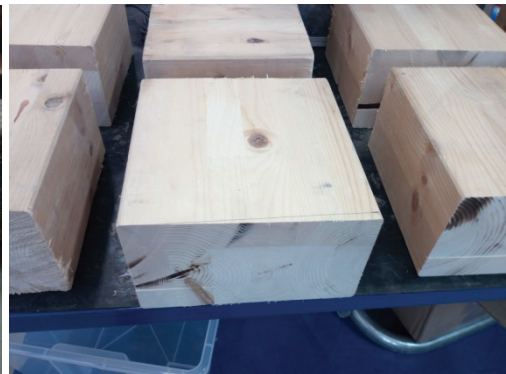
Fig. 8 – New wooden samples

In order to determine the variation in the performance characteristics of glued laminated timber elements due to exposure to atmospheric agents, an experiment that compared two sets of glued laminated wood beams was carried out in the laboratories of Tecnolab s.r.l. in Naples, the first one taken from an ancient Roman theater, set up
